## Cover for roof delamination signalling device

### Description of the solution:

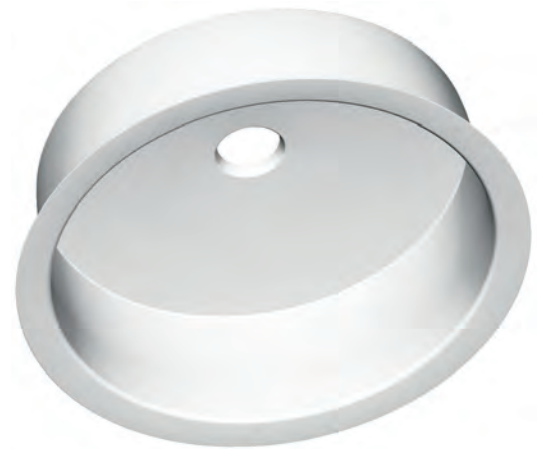
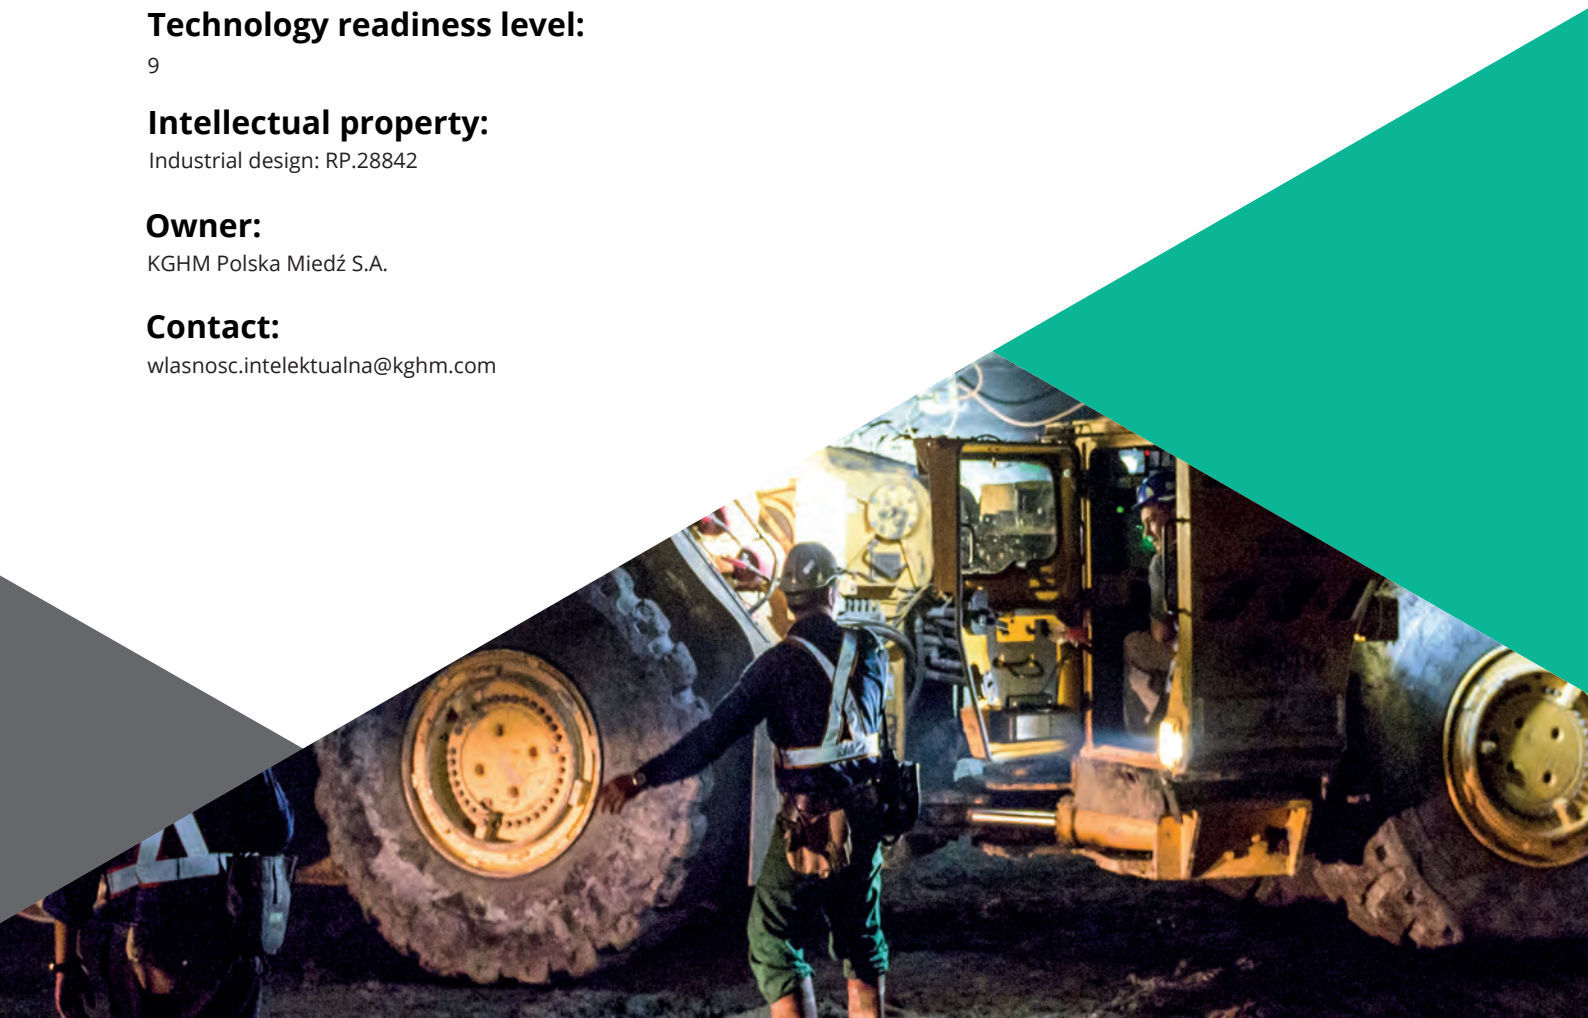
The solution takes the form of an additional cover applied over the guide sleeve, on which wooden discs are currently fitted, which signals, by sliding off the sleeve in turn, increased pressure of the roof. Until now, the discs did not have a cover against water containing minerals and salt flowing out of the signal rod hole, causing the wooden parts to stick together. This fact prevented correct signalling of the size of the delaminations. This cover effectively solves the problem of discs sticking together as a result of brine-mineral water flowing out of the roof openings onto the wooden discs of the signalling devices.
